# Outline of the Damage in Chiba Area due to The 2011 off the Pacific coast of Tohoku Earthquake

June 28, 2011  
Shoichi Nakai, Chiba University

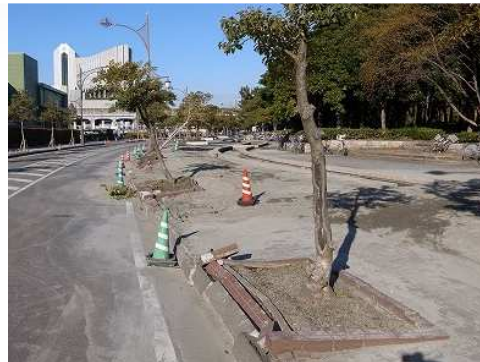
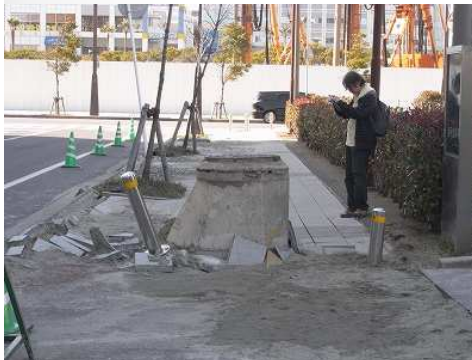
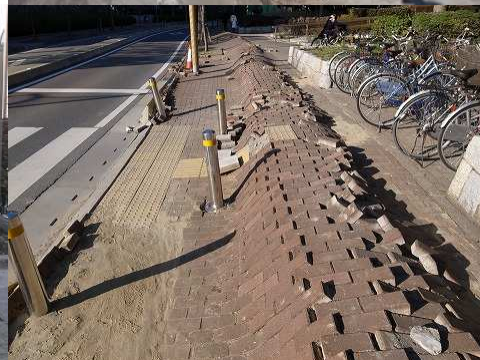
### Near Kaihin-Makuhari station

Heavy sand boiling and ground deformation along the sidewalk were observed.

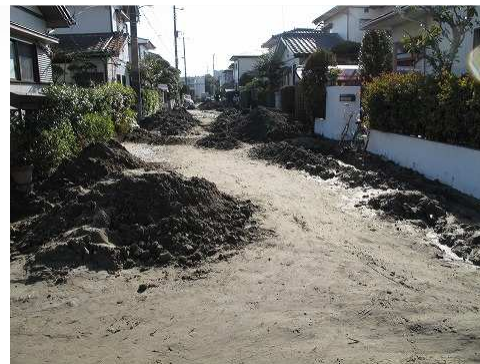
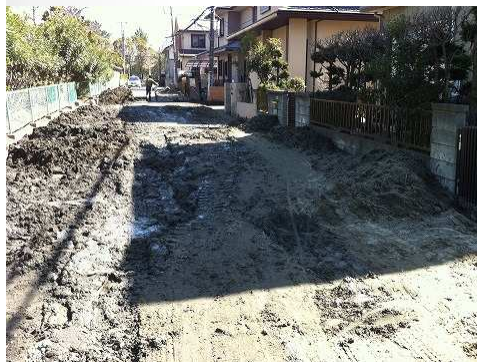
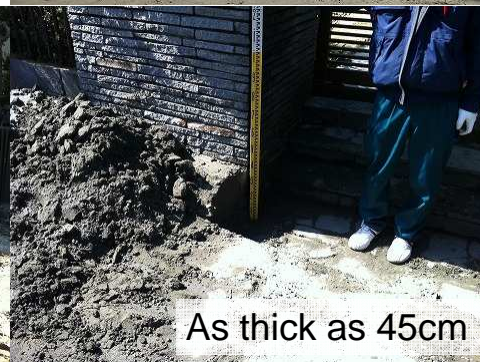
## Isobe district

Inside the residential area, a wide-spread sand boiling was observed.

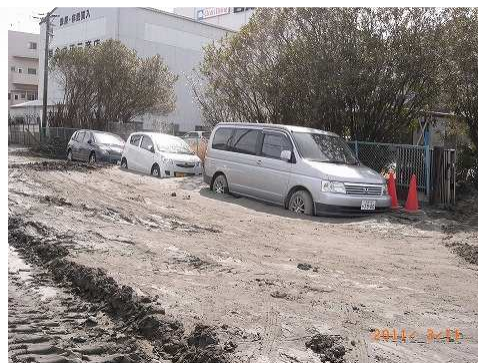
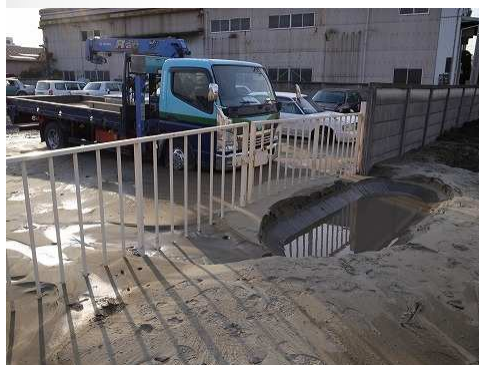
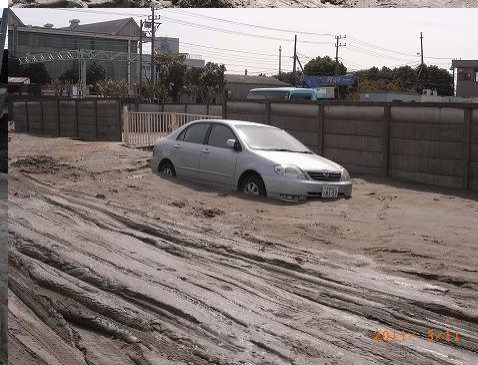
## Shinminato district

In an industrial area, a large amount of sands were blown off from the gap of the road surface.

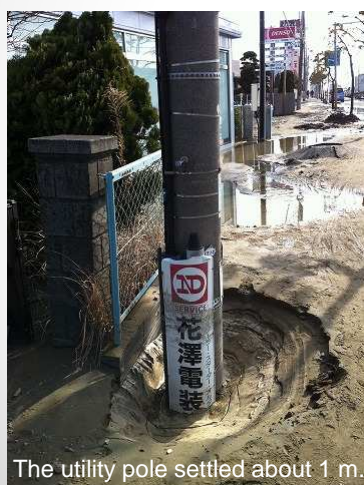
## Shin-Minato

The utility pole settled about 1 m.

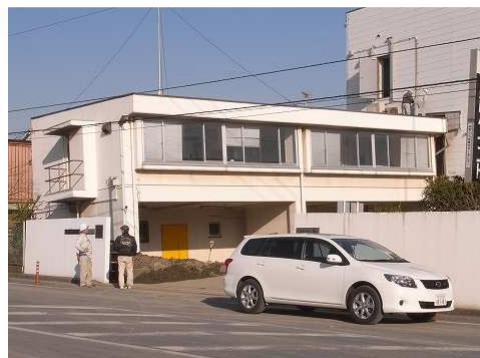
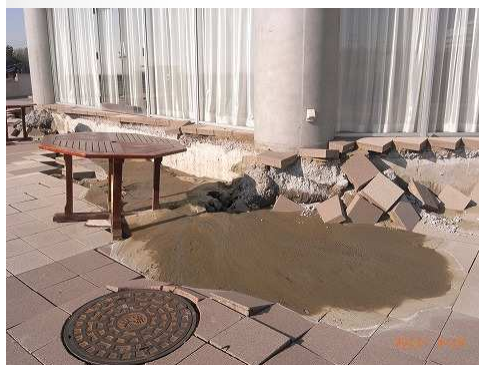
Shin-Minato

Settlement of nearby ground

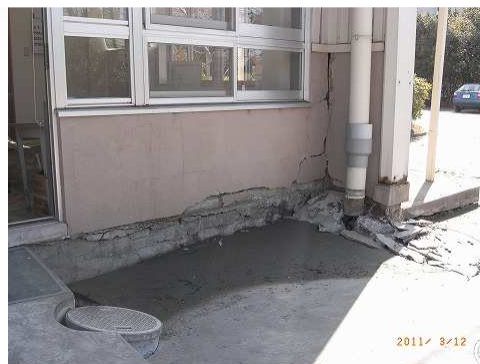
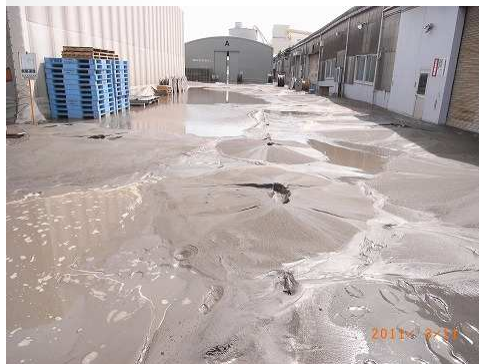
Shin-Minato

Settlement of nearby ground

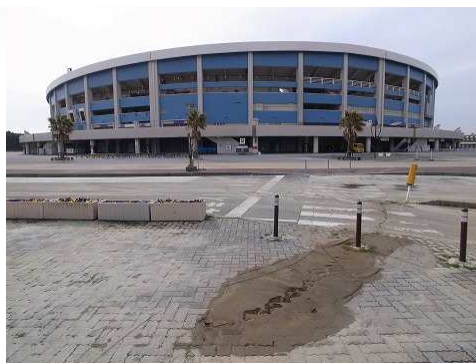
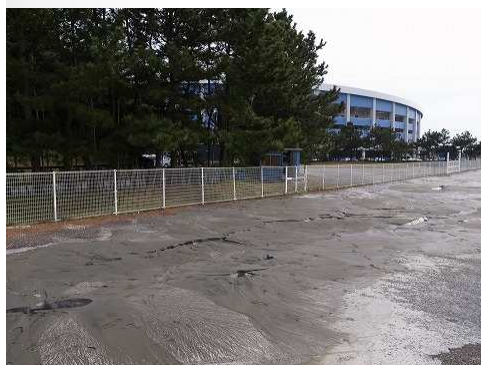
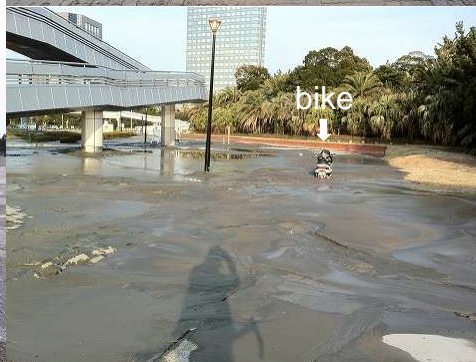
## QVC Marine Field (Baseball field)

The facility underwent restoration work until April 12, the opening day of the professional baseball game.

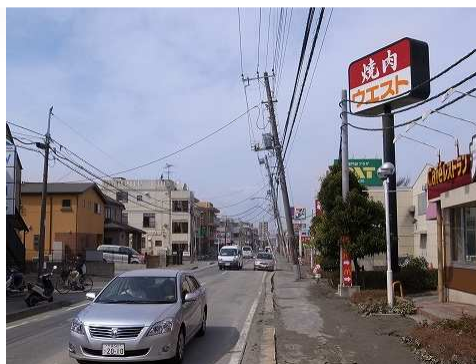
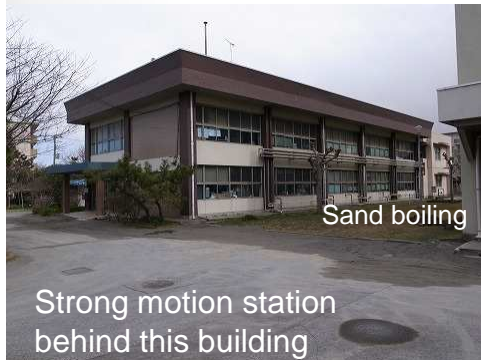
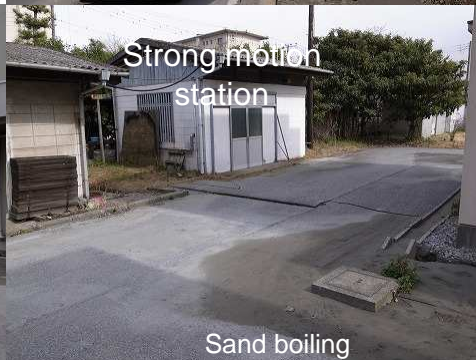
## K-NET Inage (Strong motion station)

Heavy sand boiling and several tilted utility poles were found around the strong motion station.
