ASPECTOS GEOTÉCNICOS

Universidad de Tohoku

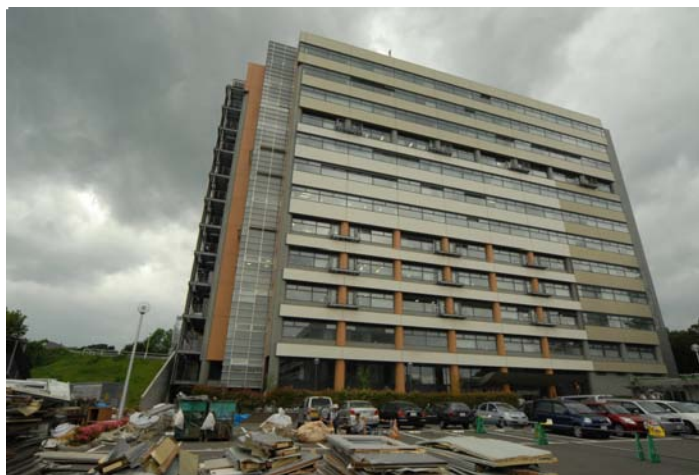
Edificio sobre pilotes de acero de 25 m

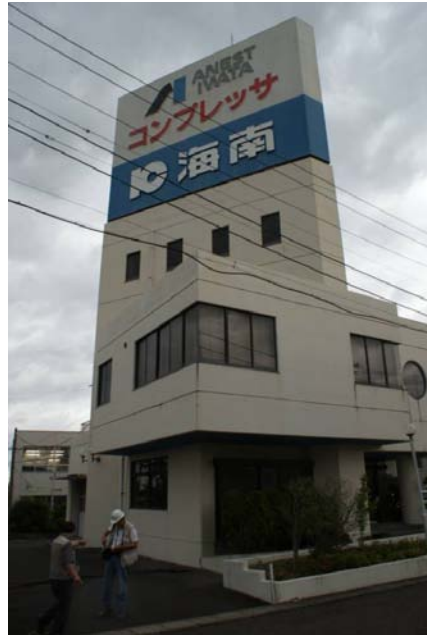
Edificios afectados en Sendai

16 pilas

Diámetro 30 cm

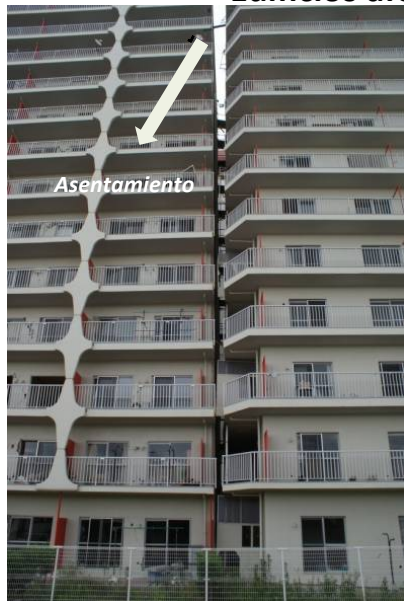
Edificios afectados en Sendai

Construido en 1976
Recimentado en 1978
Pilas de 24 m
1/45 de inclinación
90 cm de separación en la parte superior

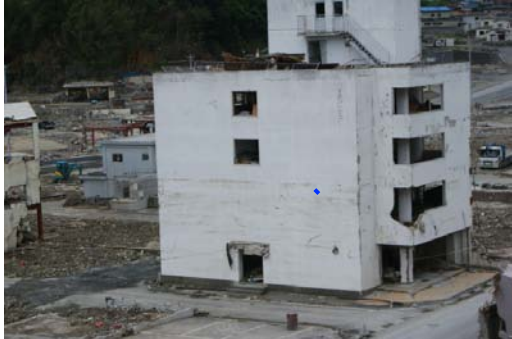
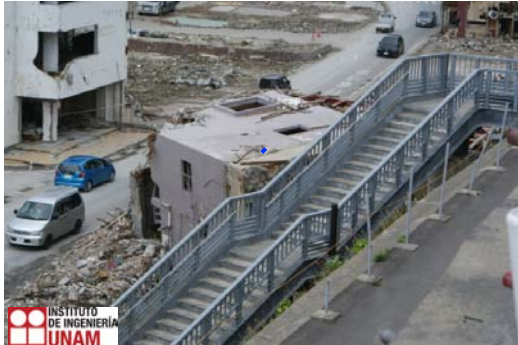
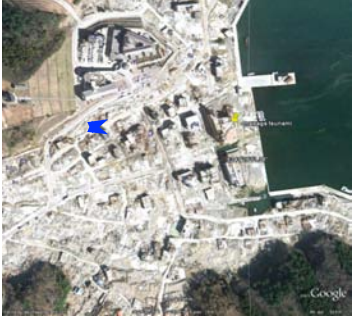
Onagawa

El edificio flotó aproximadamente 70 m

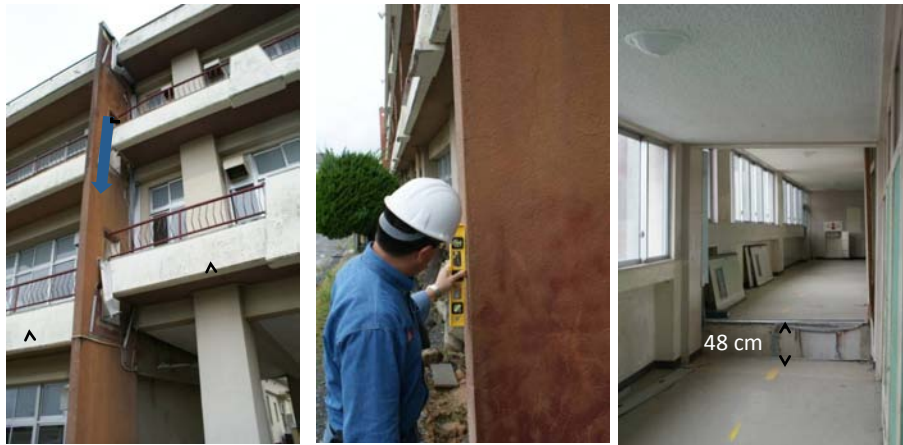
Osaki

Construido en 1979
Construido en 1990
Pilas de 20m

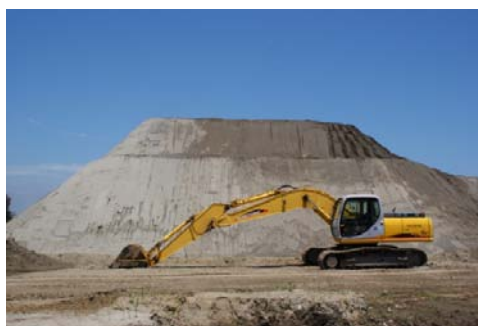
Urayasu

80.000 m³ de arena
recogidos de las calles
