# NILIM/BRI Joint Field Survey on the 2011 Off the Pacific coast of Tohoku Earthquake (the Great East Japan Earthquake)

National Institute for Land and Infrastructure Management (NILIM)  
Building Research Institute (BRI)

## Introduction

- NILIM and BRI jointly organized field survey teams in the aftermath of the Great East Japan Earthquake to learn lessons from structural damage states and then to reflect them on the future acts for mitigation.
- Total number of man-days for the surveys is more than 150.
- This presentation introduces typical damage to buildings induced by both of seismic and tsunami effects, which is illustrated in the NILIM/BRI quick survey report.

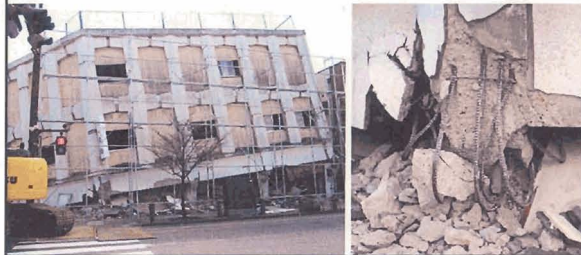
### Typical seismic damage state – RC structure (1)

- It was found that damage degree of buildings designed by the old seismic design method is not so significant compared to the recorded seismic intensity (JMA) on the site.
- However, some suffered from major damage or story collapse mainly because of shear failure of columns.

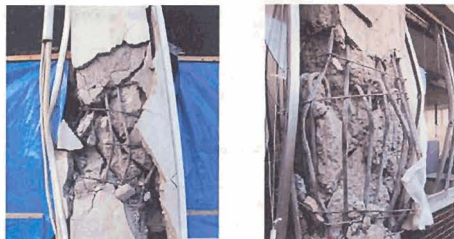
### Typical seismic damage state – RC structure (2)

- It was observed that some local government buildings designed by the old seismic design suffered from significant structural damage. This kind of damage was mainly because axial load bearing capacity was totally lost following shear failure of short column.
- They had been supposed to keep as much functionality as possible after an emergency like this disaster.

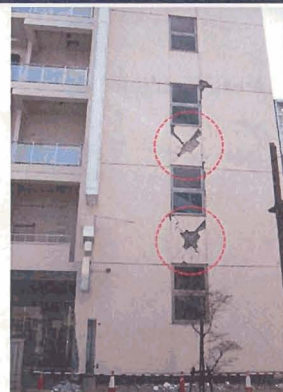
### Typical seismic damage state – RC structure (3)

- There were few examples of damage to RC buildings designed by the new seismic design method which is valid after 1981.
- Shear cracks in multi-story walls between openings were observed in some buildings.

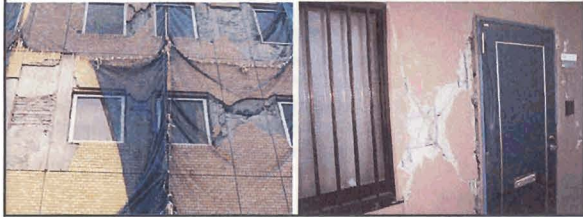
Typical seismic damage state – RC structure (4)

- Damage to non-structural elements such as exterior walls and windows was very common.
- Shear failure of non-structural walls next to the front door were also observed.

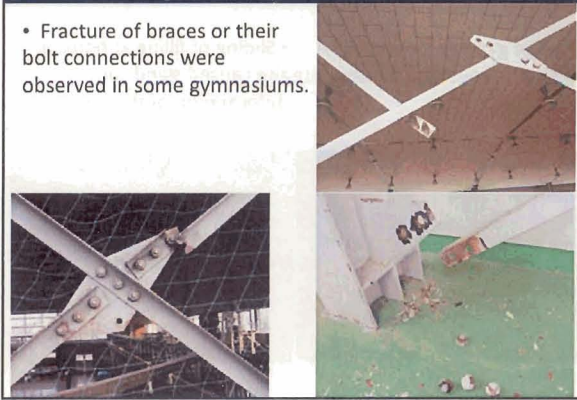
Typical seismic damage state – steel structure (1)

- Fracture of braces or their bolt connections were observed in some gymnasiums.

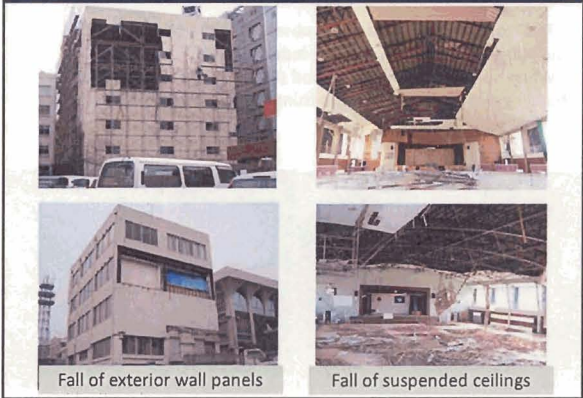
Typical seismic damage state – steel structure (2)

Fall of exterior wall panels

Fall of suspended ceilings

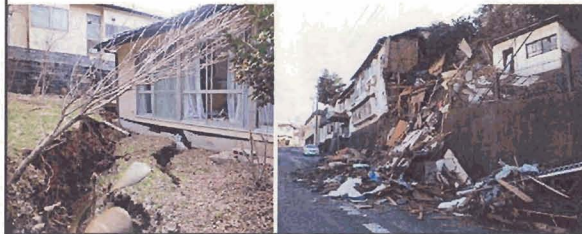
Typical seismic damage state – timber structure (1)

- Earthquake damage of ground caused failure of continuous footing.
- Slope failure of mountain caused total collapse of timber building.

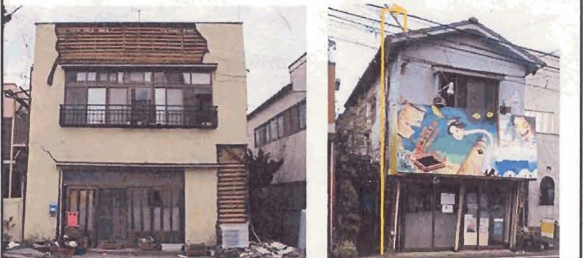
Typical seismic damage state – timber structure (2)

- Fall of exterior mortar and lath wall
- Large residual deformation

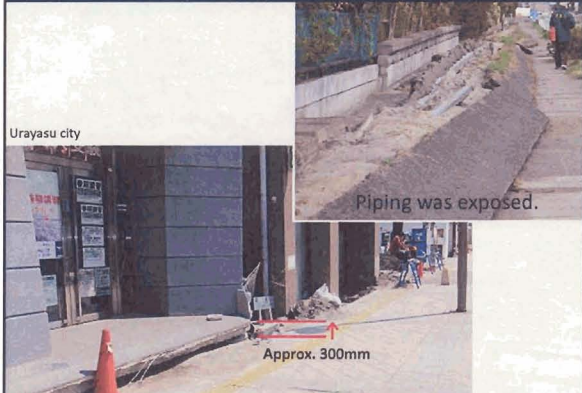
Urayasu city

Typical seismic damage state – soil liquefaction

Piping was exposed.

Approx. 300mm

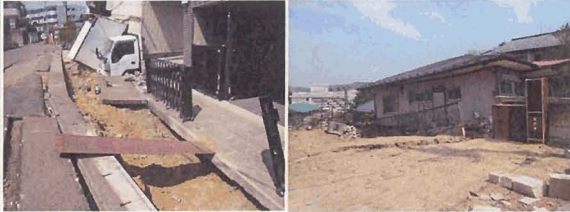
Sendai city

Typical seismic damage state – land development area

- Large gap was observed between road and housing site. site caused significant deformation of the house.
- Sliding of filling at housing site caused significant deformation of the house.

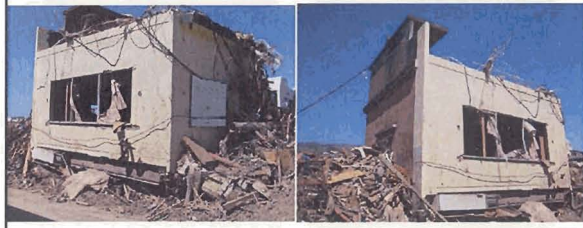
Typical damage state – RC structure (1)

- Total collapse of first story was observed in the two-story RC buildings suffering from tsunami-induced effect.
- When opening area in the second story was not so large, the building was subjected to more tsunami loads on the walls.

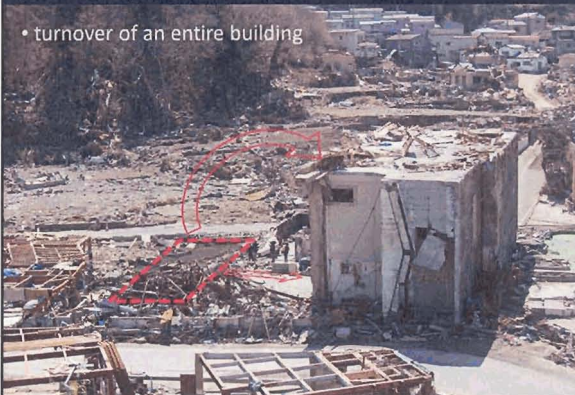
Typical damage state – RC structure (2)

- turnover of an entire building

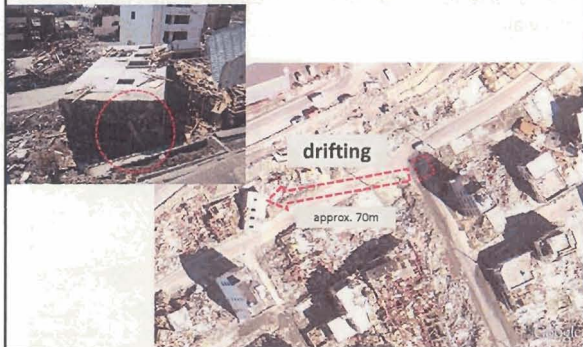
Typical damage state – RC structure (3)

- turnover and drift of an entire building

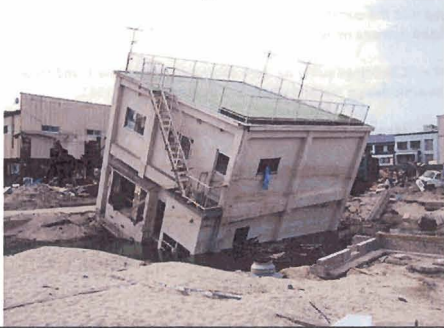
Typical damage state – RC structure (4)

- Entire building suffered from significant sinking following the effect of erosion in the ground.

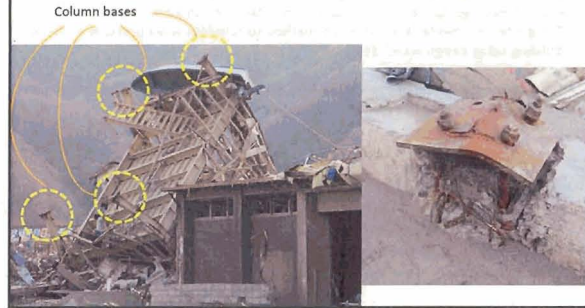
Typical damage state – Steel structure (1)

- Turnover and drift of entire building following the fracture of exposed-type column base

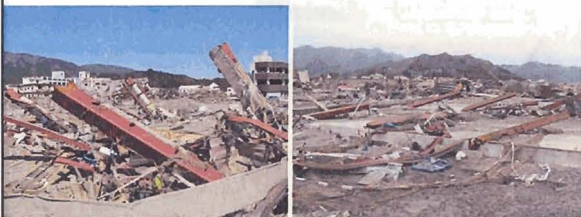
Typical damage state – Steel structure (2)

- Turnover and drift of entire building following the fracture of column capital

This type of damage was observed in the buildings whose columns have concrete encased base or imbedded type base.

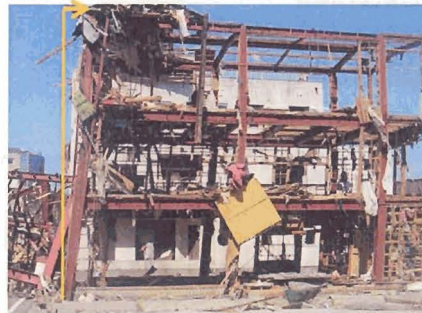
Typical damage state – Steel structure (3)

- Main columns and beams in some buildings are almost intact after all the external claddings were swept away. But they have residual deformation in columns.

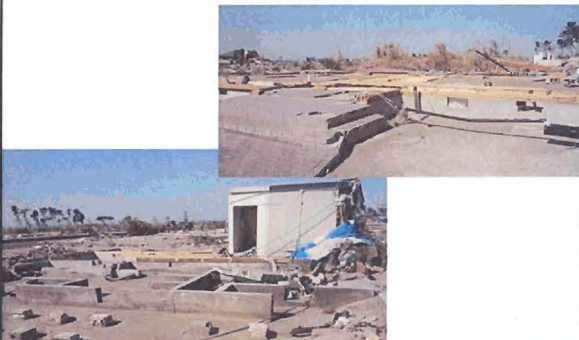
Typical damage state – Timber structure (1)

- Entire buildings are swept away.

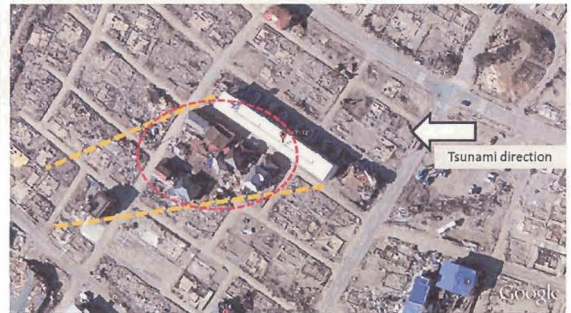
Typical damage state – Timber structure (2)

- If timber structures are located just behind a relative large-scale building, they were not swept away because of the decrease of direct tsunami effect on them.
