UNAM Briefing 2011/06/23

2011 Off Pacific Coast Tohoku Earthquake
~ Overview and Structural Damage ~

TOHOKU UNIVERSITY
DISASTER CONTROL RESEARCH CENTER
Masato MOTOSAKA

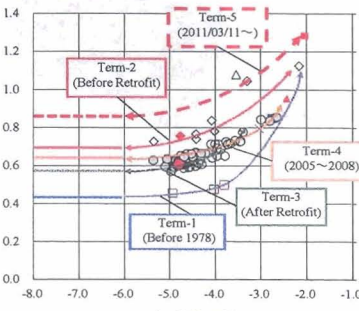
Change of natural period of the building for about 40 years after completion

Relation of natural period and deflection angle (TR direction)

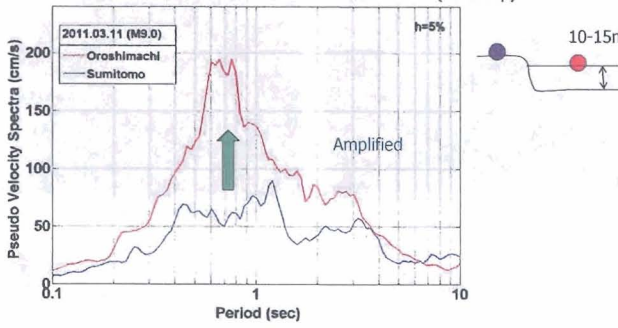
Oroshimachi (NS) and Sumitomo Building (N155E, (NS comp))

2011.03.11 (M9.0)

Amplified

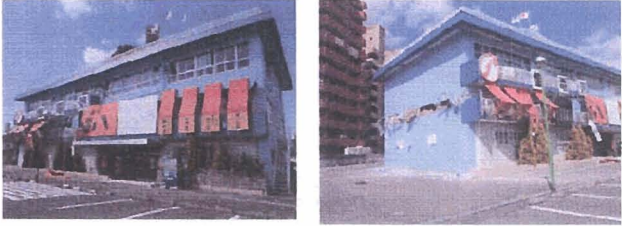
Damage of RC building in alluvium site in Yamato-machi ~Collapse of 3 story RC building

Effect of torsional motion

PGA: about 600cm/s/s

Construction year before 1981

Yamato-machi 5 chome

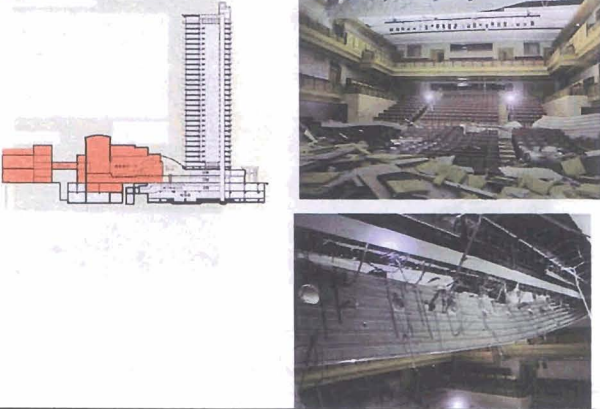
Fall of ceiling board Hall of Taihaku-ku Culture Center, Sendai

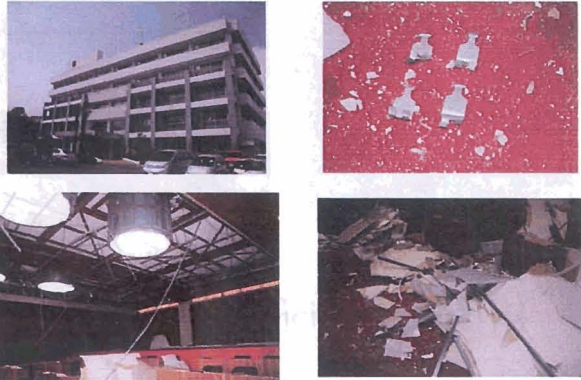
Drop of Ceiling board of municipal assembly rooms ~ Kurihara City Hall

Drop of Ceiling board of municipal assembly rooms~Shiroishi City Hall

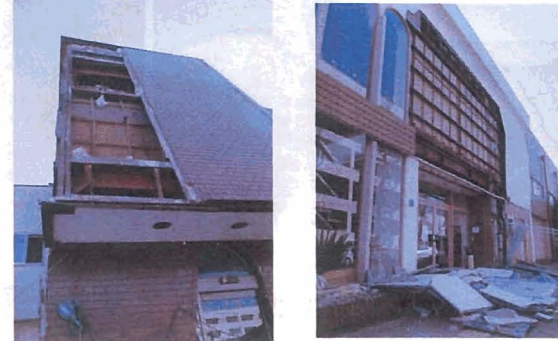
Fall of exterior wall of steel structure (Oroshimachi)

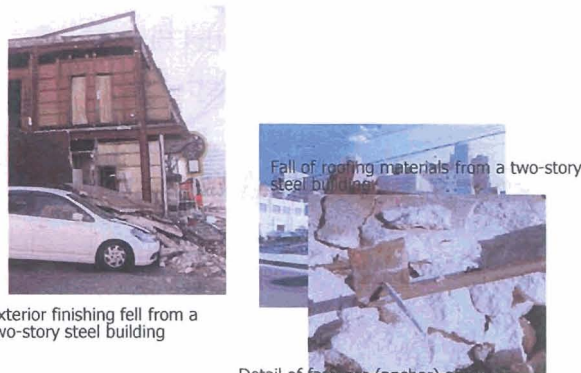
Exterior finishing fell from a two-story steel building

Fall of roofing materials from a two-story steel building

Detail of fastener (anchor) of failed ALC exterior wall

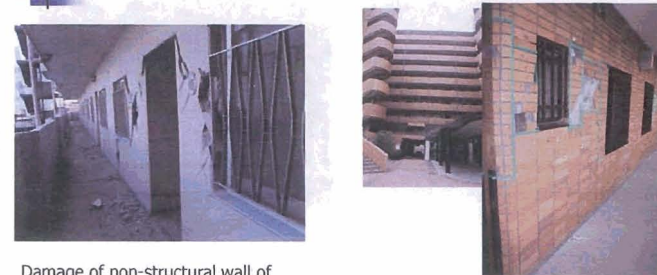
Damage of non-structural wall of 14 story RC building in Yamato-machi, Sendai

Damage of non-structural wall of 10 story RC building in Kashiwagi-machi, Sendai

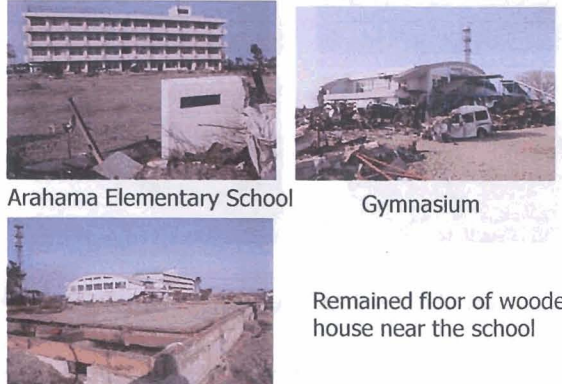
Arahama Elementary School Gymnasium

Remained floor of wooden house near the school

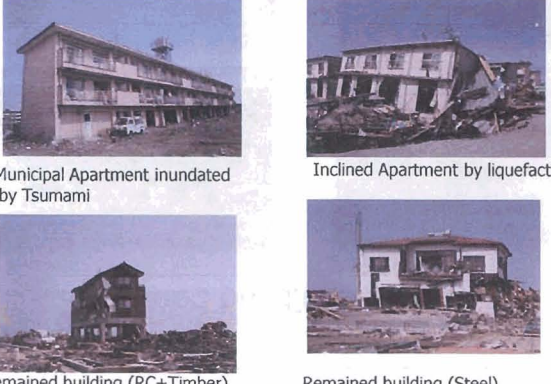
Municipal Apartment inundated by Tsumami Inclined Apartment by liquefaction

Remained building (RC+Timber) Remained building (Steel)

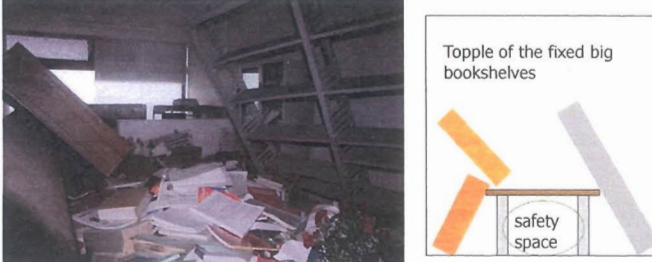
Prof. Motosaka's office after the 3.11 earthquake

Topple of the fixed big bookshelves

*Surging 'Book wave' due to vibration with 3 minutes duration
*Inside-open door blocked to escape
