# NILIM/BRI Joint Field Survey on the 2011 Off the Pacific coast of Tohoku Earthquake (the Great East Japan Earthquake)

National Institute for Land and Infrastructure Management (NILIM)  
Building Research Institute (BRI)

## Introduction

- NILIM and BRI jointly organized field survey teams in the aftermath of the Great East Japan Earthquake to learn lessons from structural damage states and then to reflect them on the future acts for mitigation.
- Total number of man-days for the surveys is more than 150.
- This presentation introduces typical damage to buildings induced by both of seismic and tsunami effects, which is illustrated in the NILIM/BRI quick survey report.

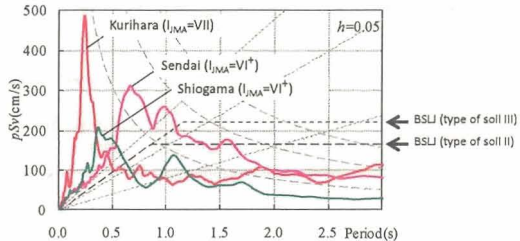
In Kurihara city, where seismic intensity of VII was recorded, predominant spectrum is observed in short period, i.e. less than 0.3s. But the power of spectrum in long period is lower than the limit value regulated in BSL (Building Standard Law of Japan) seismic design.

Pseudo-velocity response spectrum at some K-NET observe points where seismic intensity of more than VI was recorded.

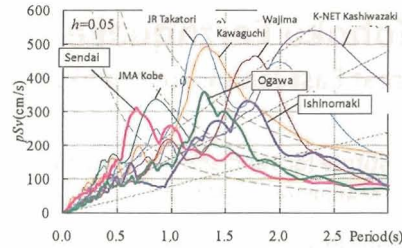
Spectrum characteristics in Sendai is similar to that in JMA Kobe recorded at 1995 Kobe earthquake.

The peak values of the spectrum recorded at several K-NET points is not so larger than those recorded at past great earthquakes.

Comparison of pseudo-velocity response spectrum
