# Outline of the Damage in Chiba Area due to The 2011 off the Pacific coast of Tohoku Earthquake

June 28, 2011  
Shoichi Nakai, Chiba University

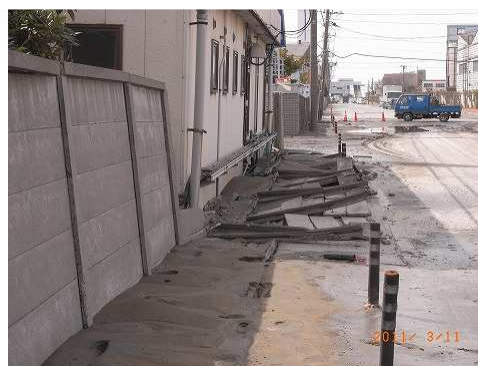
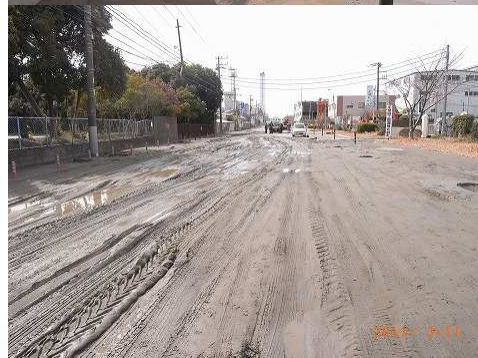
Shin-Minato

The utility pole settled about 1 m.
